Electrical Safety Audit Report

Sindhi Institute College and School

6th to 8th October 2022

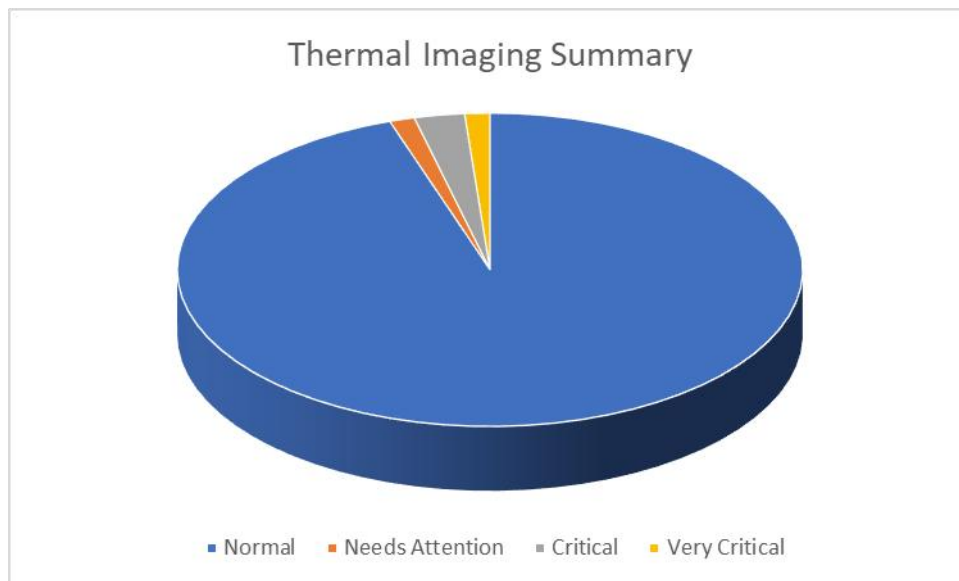
Temperature range (°C)		Condition	Nos.
Air-Conditioned area	Non-Air-Conditioned area		
≤ 35 °C	≤ 45 °C	Normal	73
> 35 °C to ≤ 50 °C	> 45 °C to ≤ 60 °C	Needs Attention	1
> 50 °C to ≤ 90 °C	> 60 °C to ≤ 100 °C	Critical	2
> 90 °C	> 100 °C	Very Critical	1
